Subject: Weekly Monitoring Report for Week Ending 09/21/2019
Florence Copper, Production Test Facility
Aquifer Protection Permit No. 106360, LTF 61845

Florence Copper is submitting this report in accordance with Table 4.1-8 and Section 2.7.4.4 of the Production Test Facility Temporary Aquifer Protection Permit (APP) No. 106360.

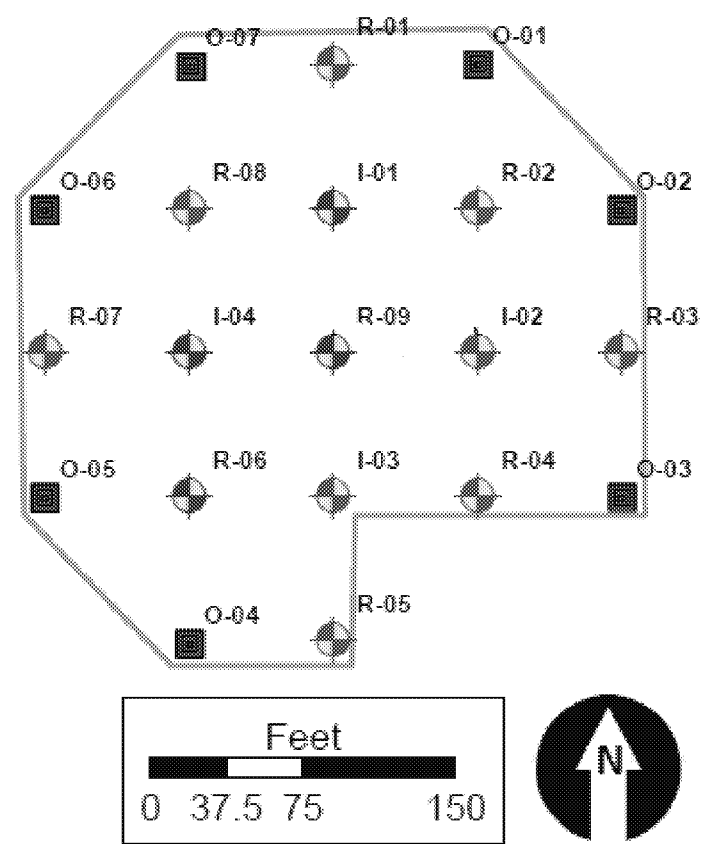
Figure 1. PTF injection, recovery, and observation well locations

A map showing the location of the PTF injection, recovery, and observation wells is included as Figure 1.

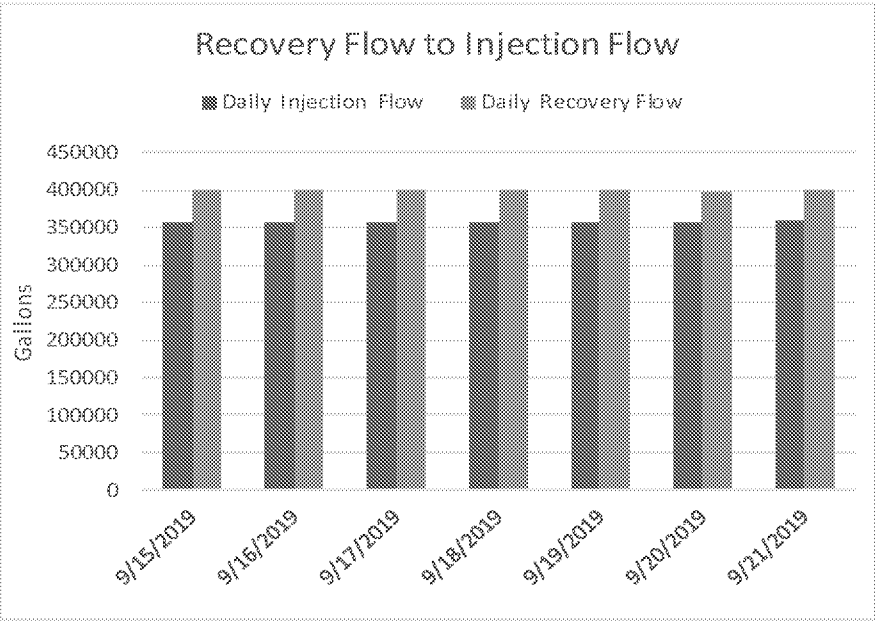
During the reporting period no exceedance of the alert level was measured for recovered volume to injected volume. The alert level is the recovered volume shall exceed the injected volume.

Figure 2. Recovered volume to injected volume

A summary of the injected and recovered volumes for the week of 09/15/2019 to 09/21/2019 is included in Table 1. The total injected and recovered volumes for the PTF as a daily total are also presented on Figure 2.

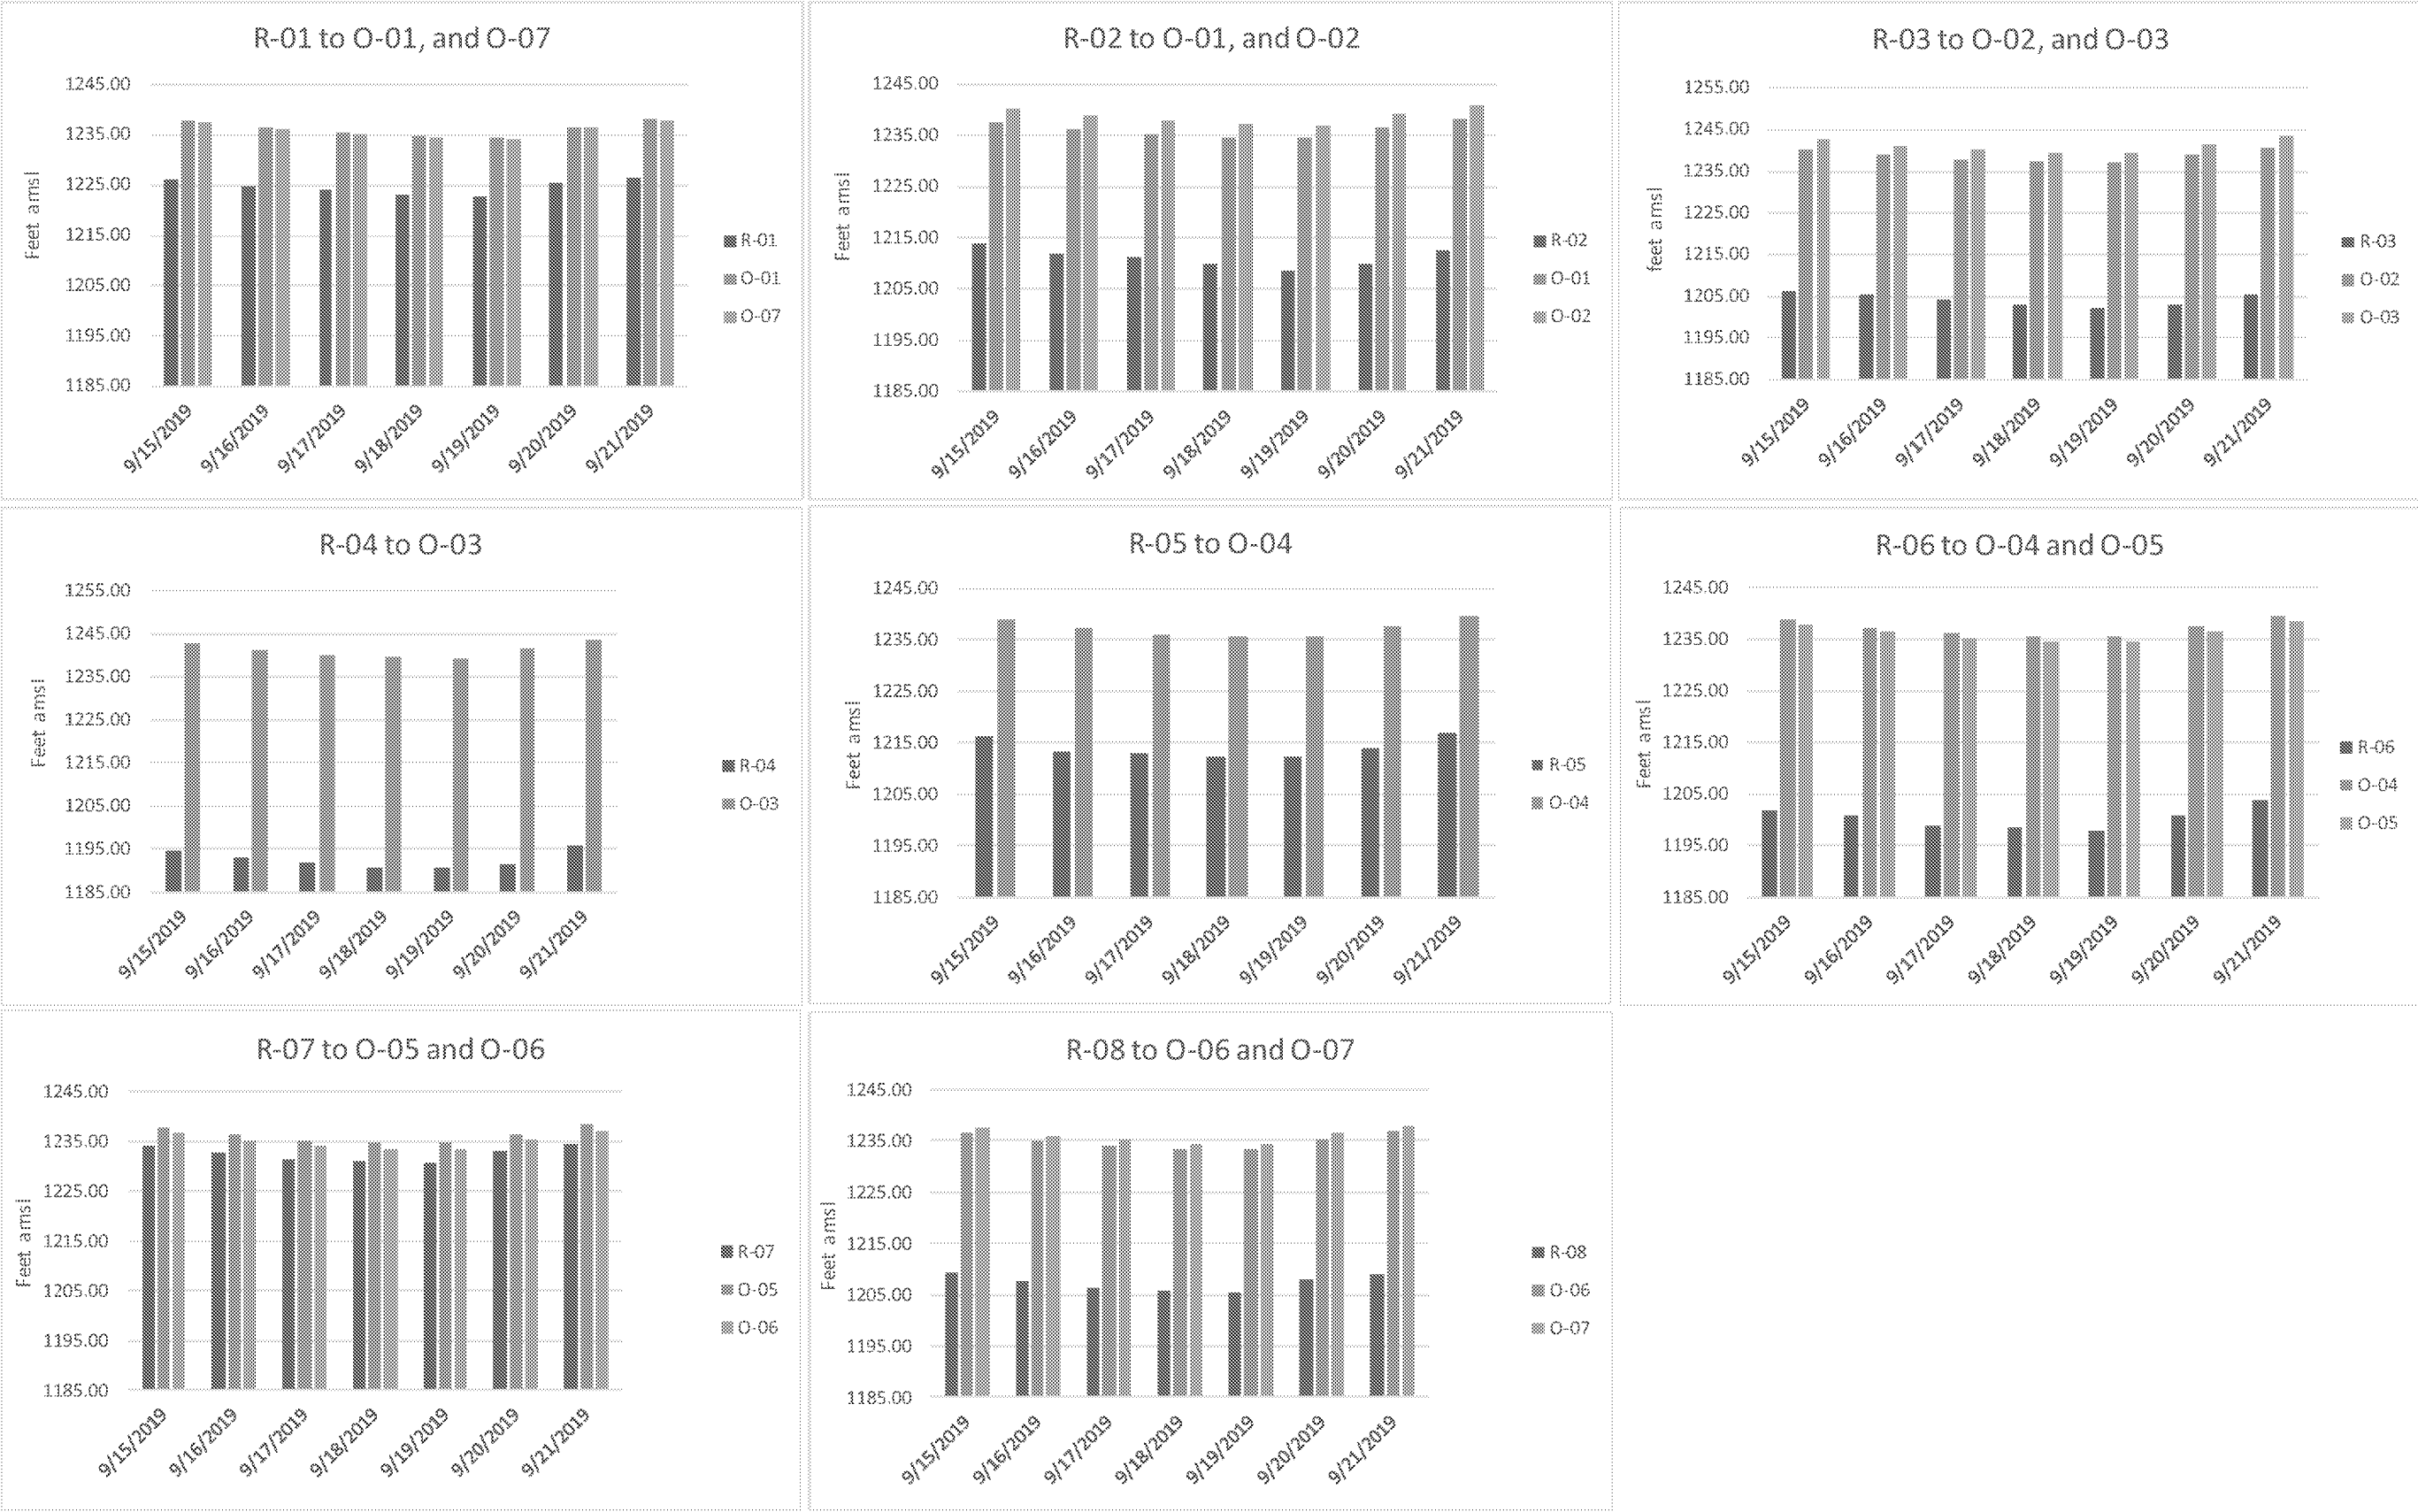
Figure 3

During the reporting period, there was no exceedance of the alert level for the inward hydraulic gradient. The alert level for the inward hydraulic gradient is that the water level elevation in the paired observation well must be a minimum of 1 foot higher than the paired recovery well.

Figure 3. Recovery and observation well pairs

Table 2 includes a summary of water levels in the recovery and observation well pairs. Hydrographs showing the water level elevation for each recovery well and observation well pair are included in Figure 3.
